Chatham East-Facing Shoreline: Coastal Resiliency and Management Assessment

June 27, 2019

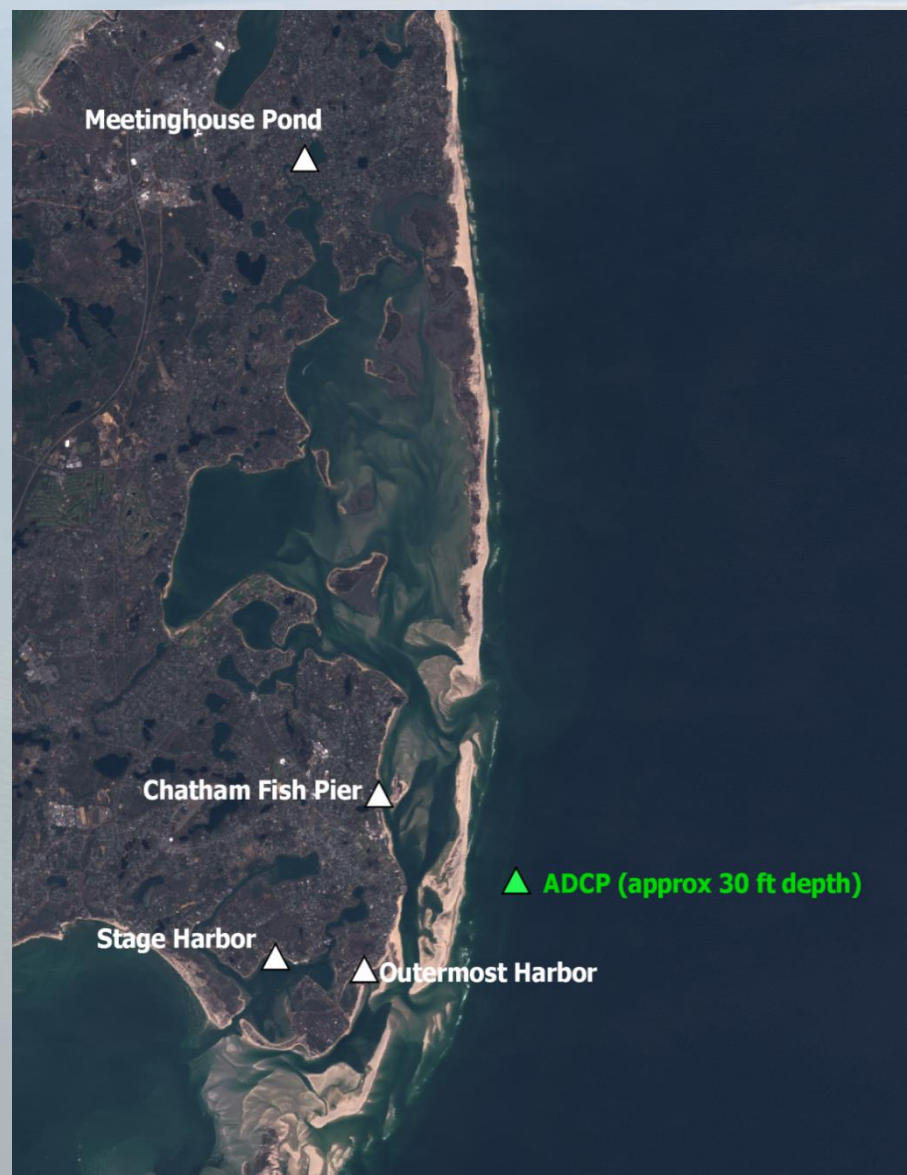
Model Development: Tidal Data Collection and Adjustment

2045 Tides were adjusted for Sea Level Rise of
0.5 feet from present

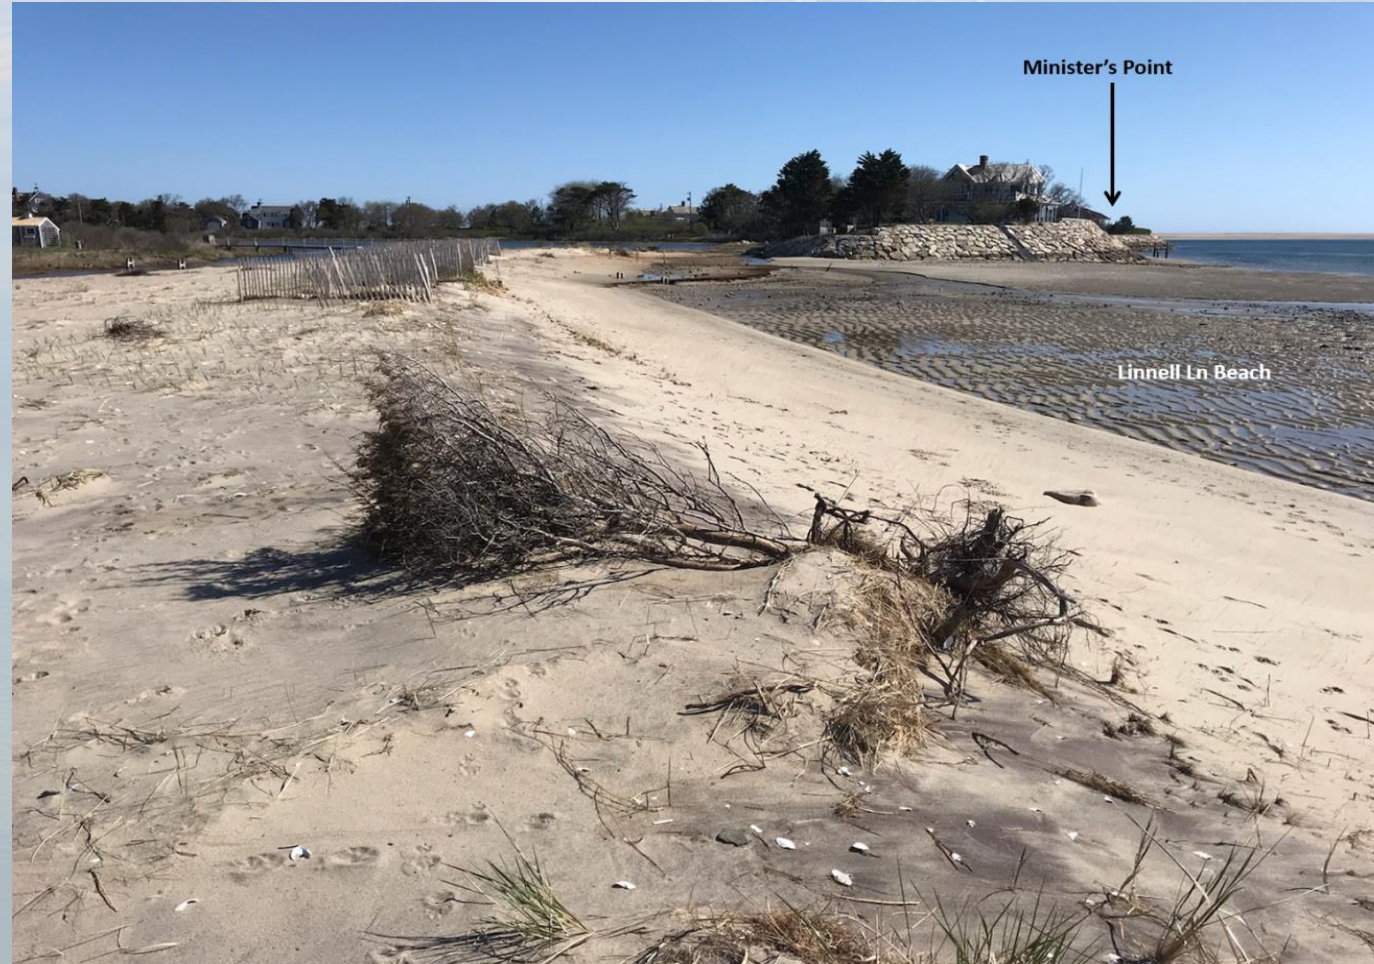
Minister's Point to Linnell Lane Beach, Assessment Area 1

Linnell Lane Beach facing north, showing the low-lying overwash area, continuous revetment at Minister's Point, and eroded beach face and exposed marsh peat layer

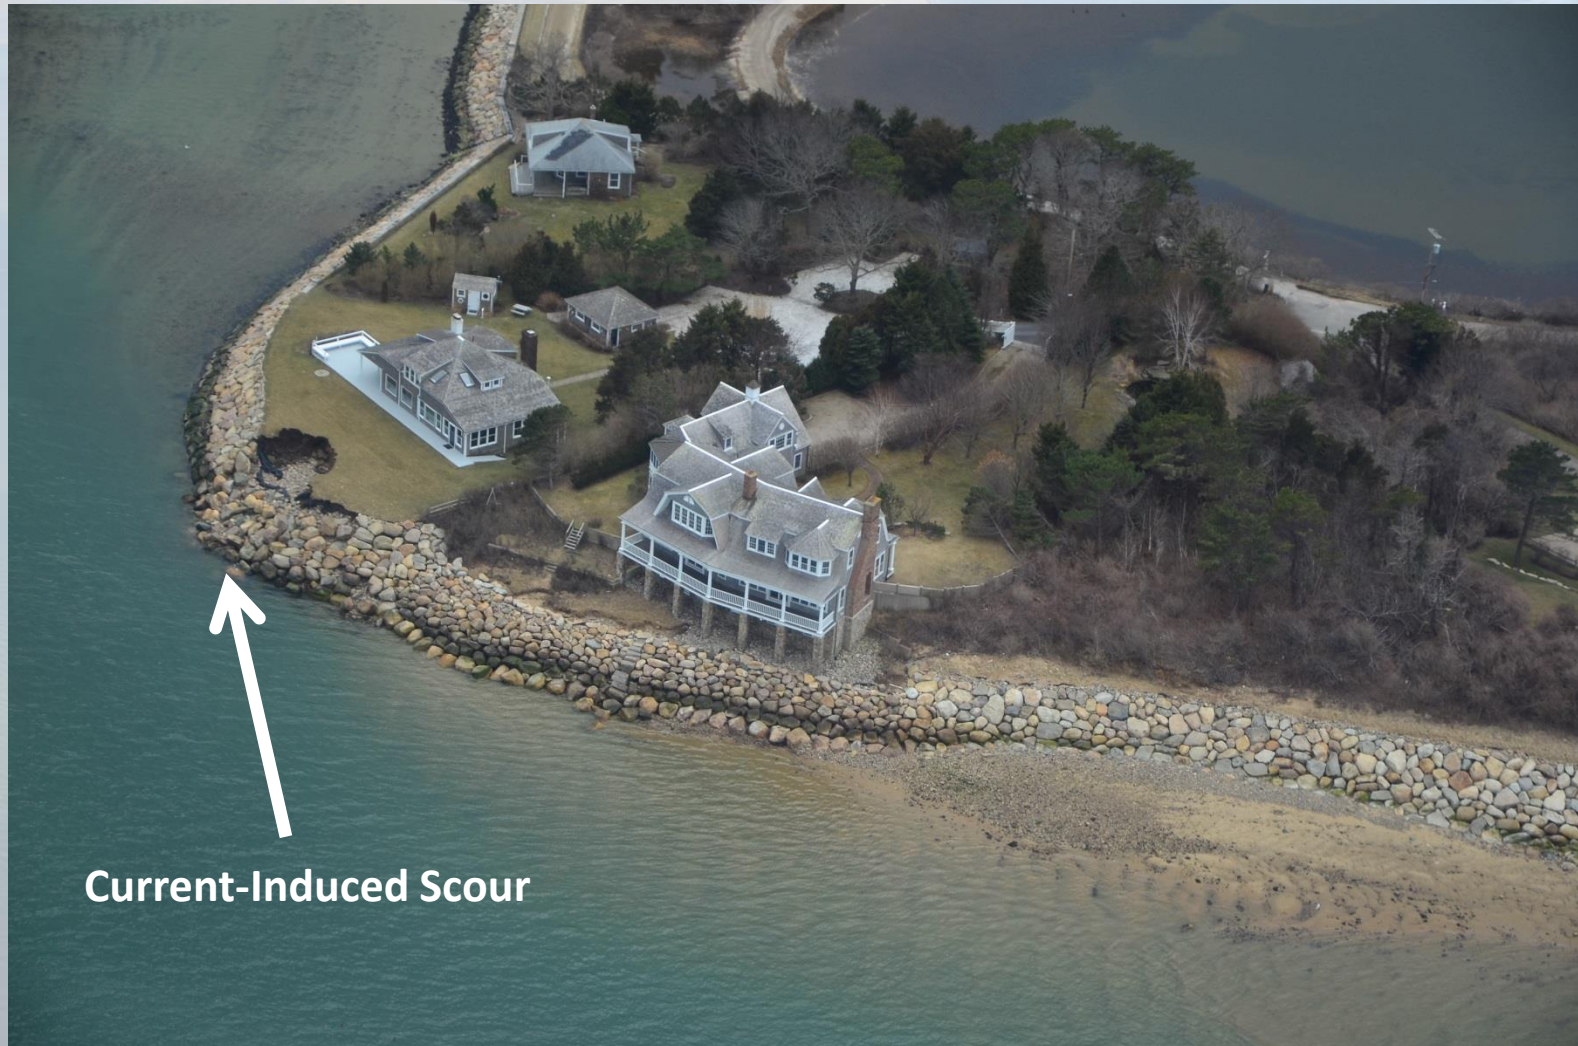
Management Strategy: Minister's Point to Linnell Lane Beach Assessment Area 1

Minister's Point Revetment

Assessment Area 1: Stabilize Revetment Toe

Pros <ul style="list-style-type: none">• Direct protection of dwellings on Minister's Point	Cons <ul style="list-style-type: none">• Potential increased scour due to tidal currents• Cost
Challenges <ul style="list-style-type: none">• Potential regulatory concerns regarding seaward encroachment on resource areas, etc.

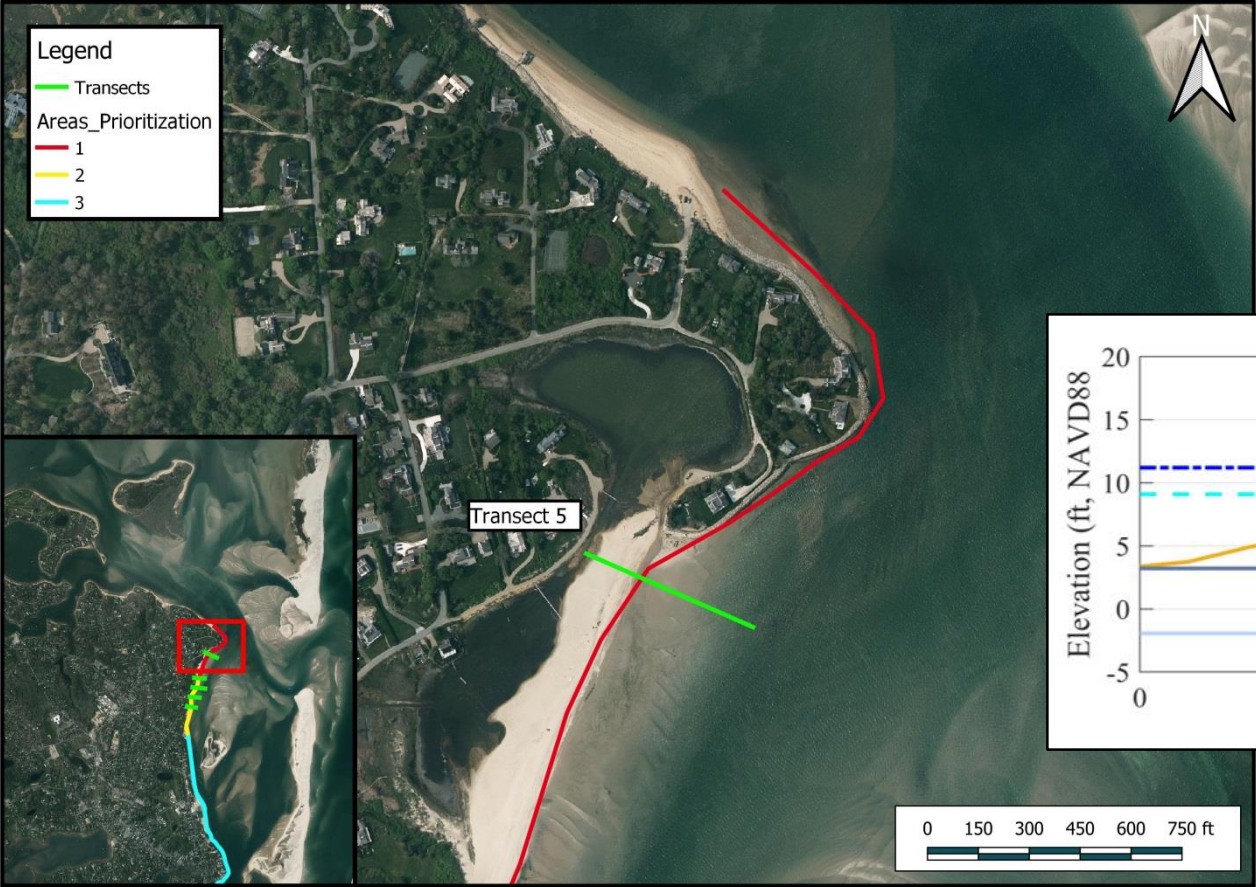
Management Strategy: Minister's Point to Linnell Lane Beach Assessment Area 1

Beach Nourishment

~32,000 cubic yards

Assessment Area 1: Linnell Lane Beach Nourishment

- Prevent storm-induced overwash into salt marsh and Linnell Lane area
- Provide sediment supply to downdrift beaches

- Increased sediment supply will make maintaining inlet to the salt marsh difficult (may require a culvert)
- Maintenance costs until North Inlet migrates further south

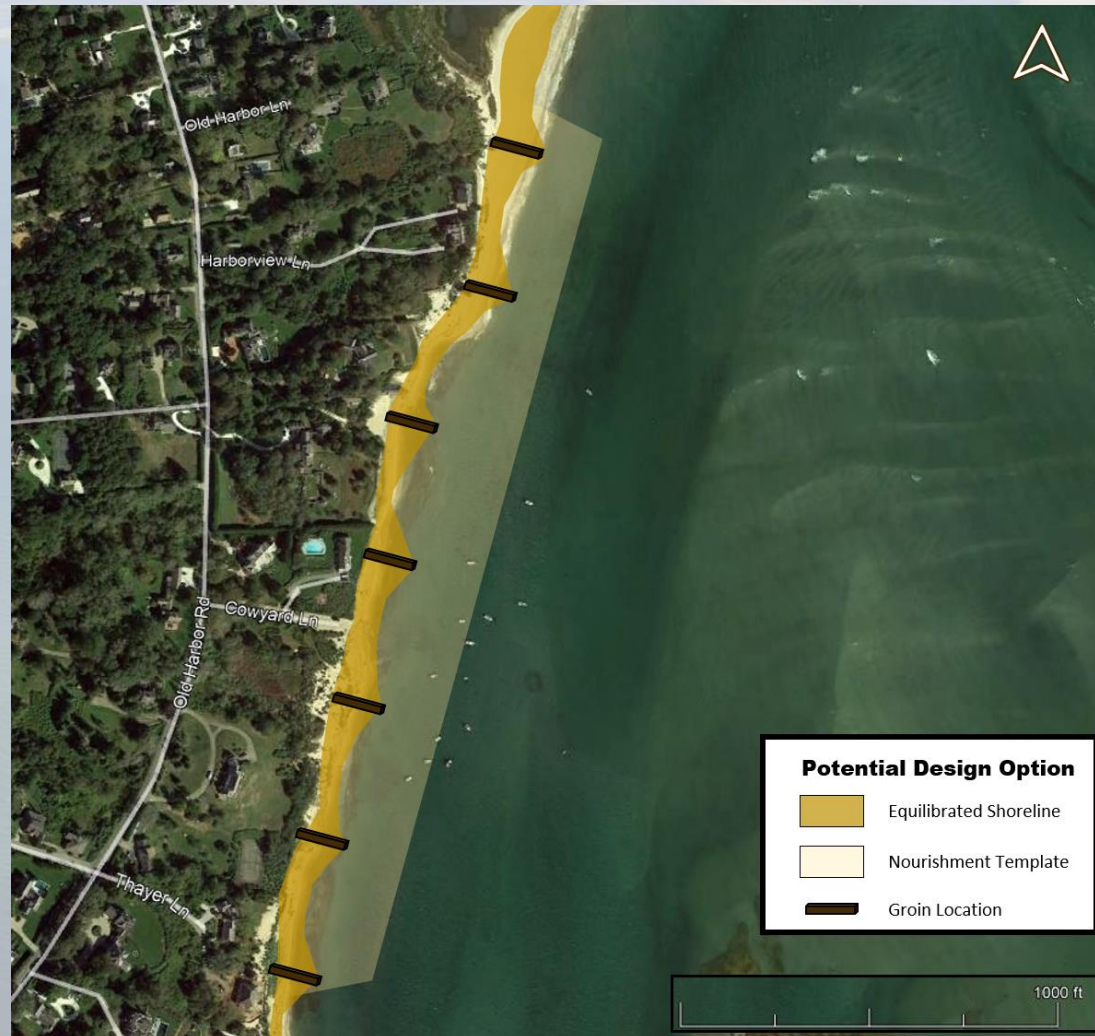
Management Strategy: Linnell Lane Beach to Thayer Lane, Assessment Area 2

- Series of temporary wooden groins constructed landward of existing MHW line
- Berm nourishment of upper beach to prevent overwash during moderate storms
- Anticipated construction sequence from north-to-south, as needed
- Removed when no longer needed

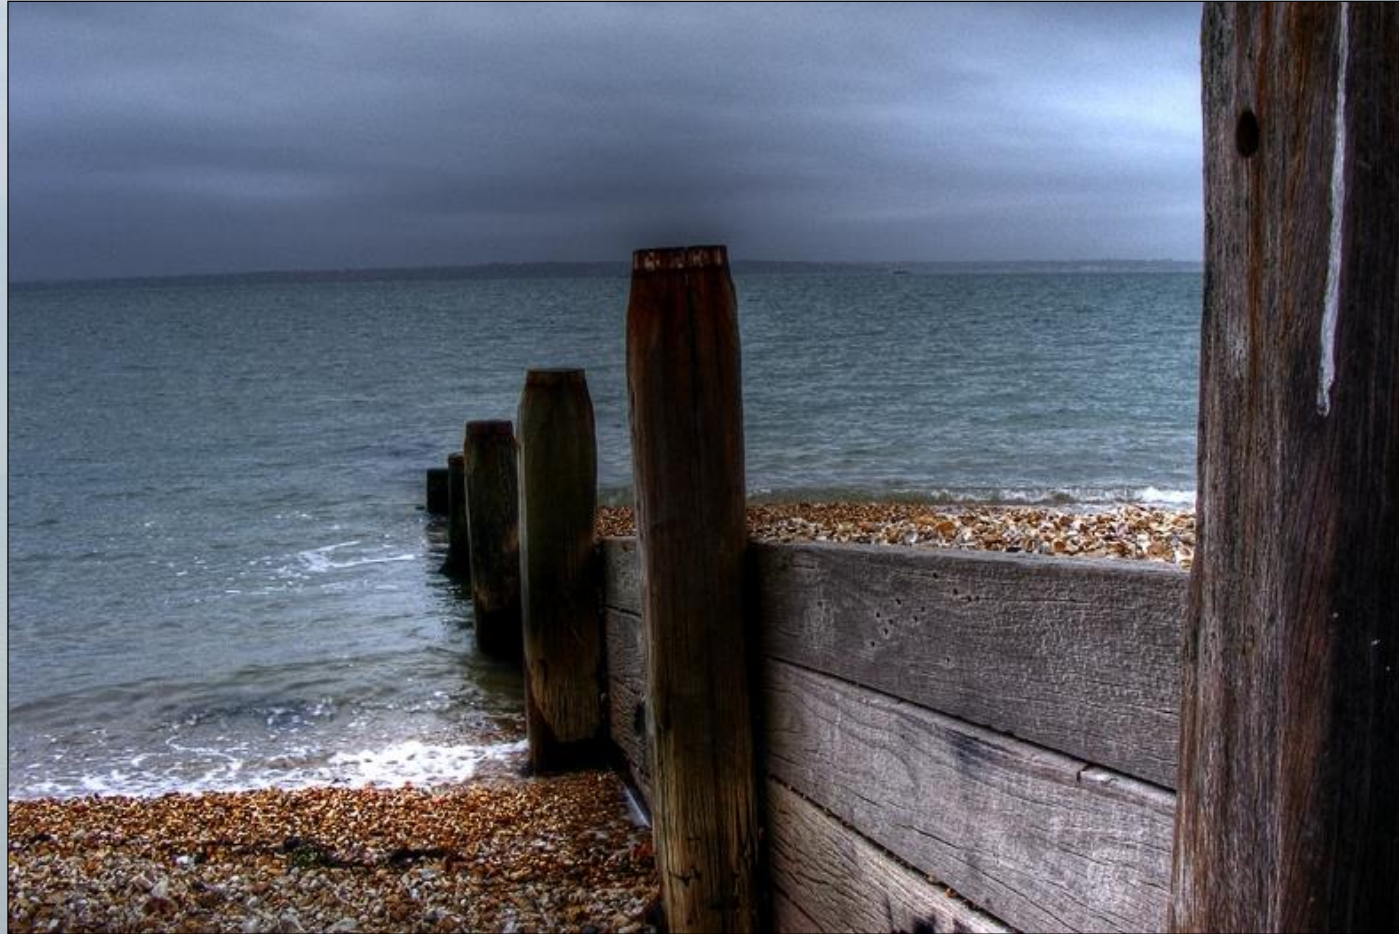
Management Strategy: Linnell Lane Beach to Thayer Lane, Assessment Area 2

Example Wood Groin

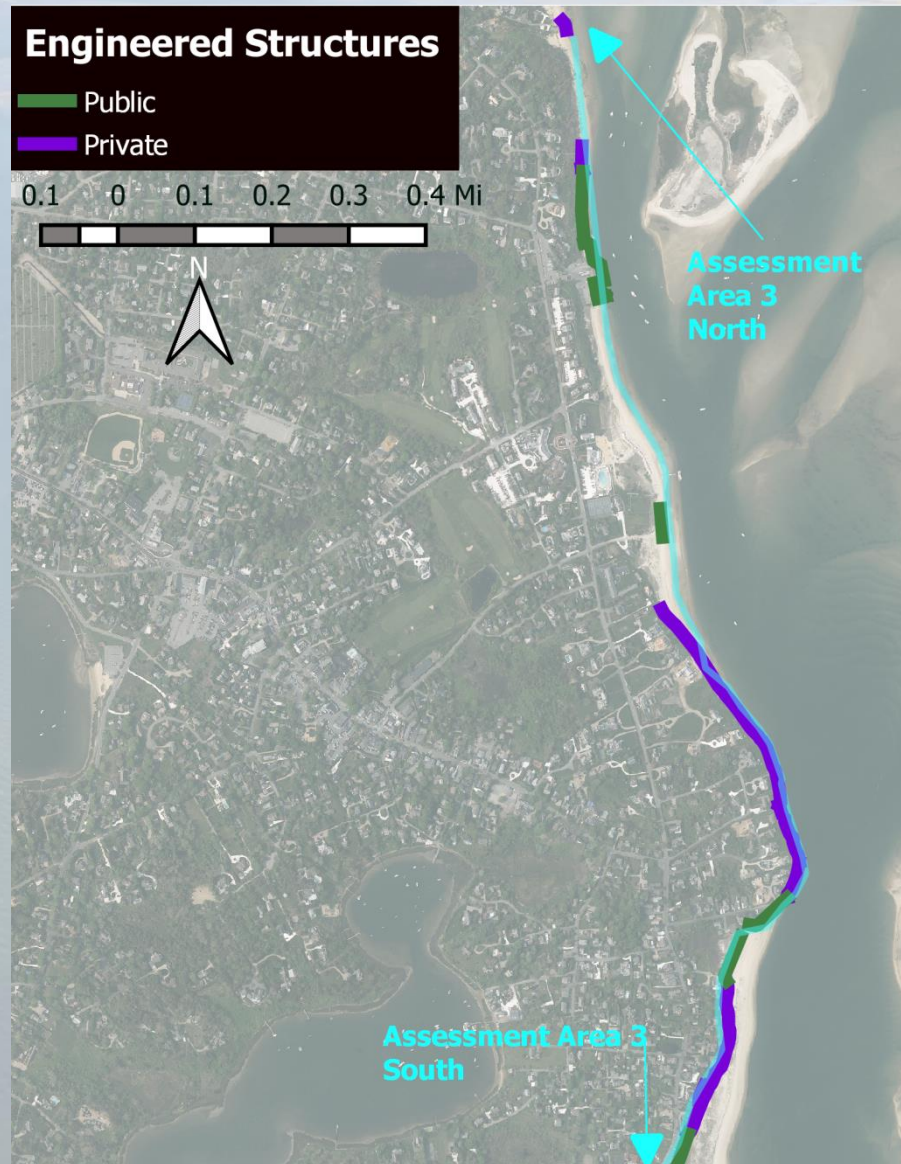
Existing Engineered Structures Assessment Area 3

- Much of shoreline is already protected by coastal engineering structures
- Many revetments were improved following the 1987 formation of South Inlet
- In recent years, storm damage to this area has been relatively minor

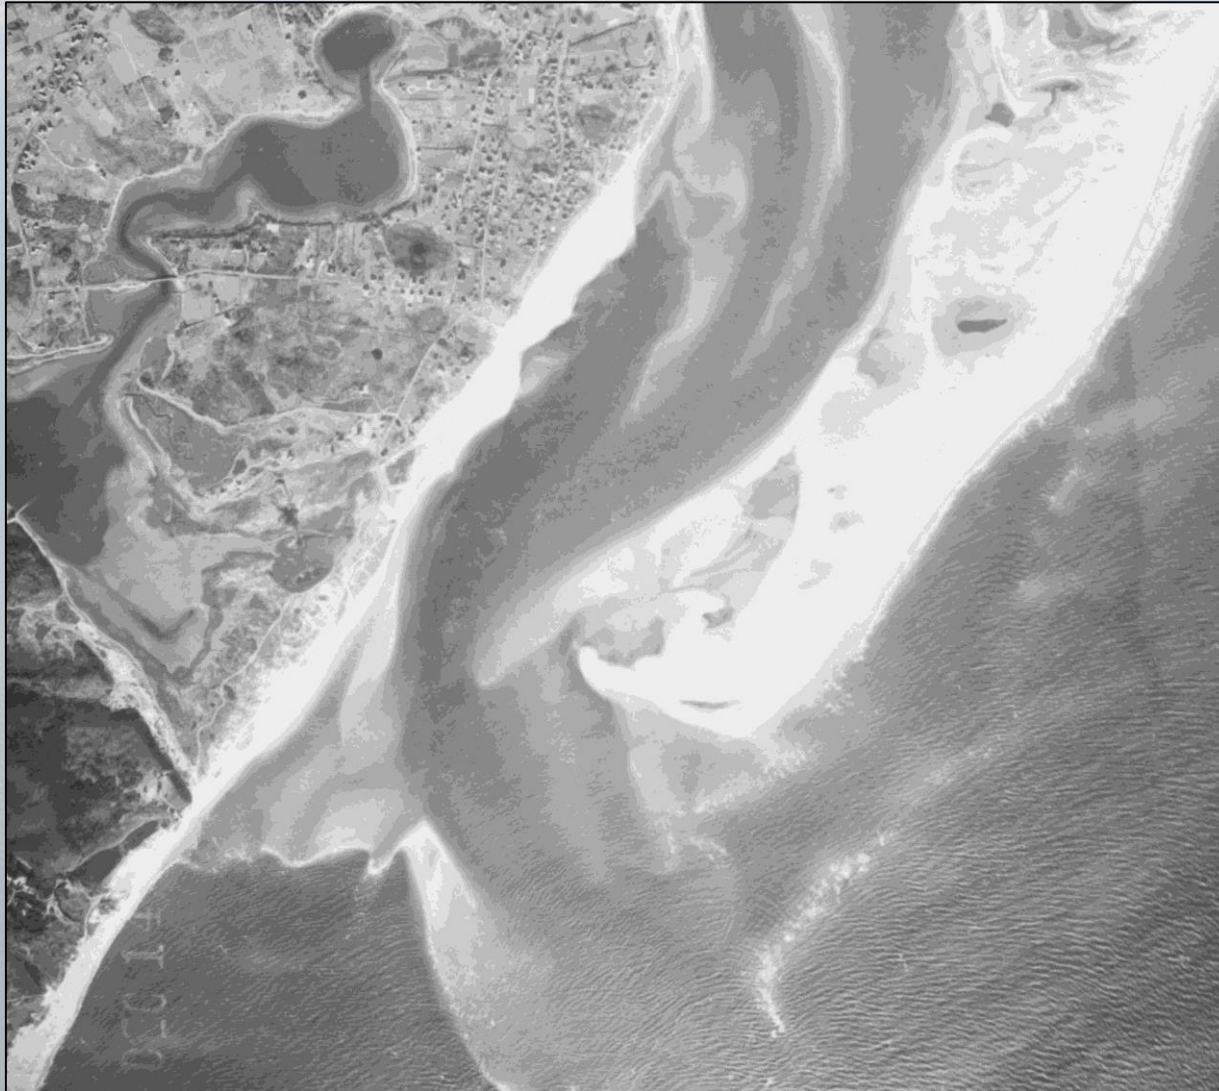
Management Strategy: Little Beach/Outermost Harbor, Assessment Area 4

**1938 Aerial:
Contiguous wide beach in area
of Outermost Harbor Marina**
